RE: Concerns Regarding Levee Breach on Victoria Island

As a follow-up, we would like to bring to the attention of the EPA a near-miss levee failure that occurred on the 21st of October 2024 on Victoria Island, where an additional Class VI permit application for CO2 injection is under consideration.

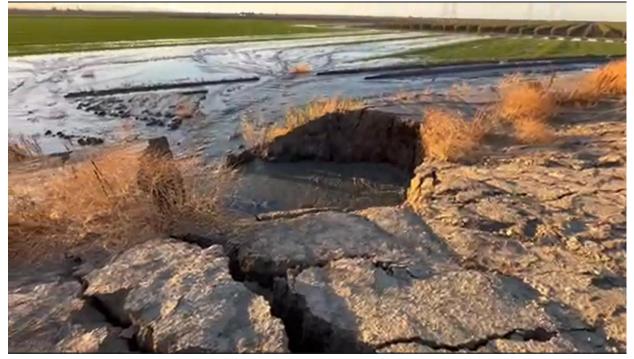
The images below show part of the levee fracture. In the first image, whirlpools in the river demonstrate movement of water into the levee.

The near-miss levee failure occurred at the southern tip of the island, adjacent to the Clifton Court Forebay, which provides storage and regulation of flows into the Banks Pumping Plant, which pumps water from the Delta into the California Aqueduct. We learned from local Delta engineers that a full levee break was very close: the initial report was that 180 feet of levee had dropped in elevation by approximately 4 to 5 feet, with large fissure cracks and a boil flowing more than 5,000 gallons per minute at the toe of the levee. Engineers reported this was indicative of a classical failure mode that typically leads to a complete collapse of the levee, then a full breach, similar to a levee failure at Upper Jones Tract in 2004.

To save and reconstruct the levee, engineers worked late into the night coring the levee on the waterside slope placing bentonite gel (expansive clay) and levee seal material in the trench. Since this initial filling effort could not stop the seepage, responders had to barge in additional material and equipment. It took three days of nonstop labor to reconstruct the levee and rebuild the failed fill section fully. The cause of the near breach was attributed to under-seepage much deeper in the levee section, likely through a sand boil.
